## YUCCA MOUNTAIN PROJECT

# STRATEGIES FOR RECOVERY AFTER AN OFF-NORMAL EVENT TO THE WASTE PACKAGE TRANSPORT AND EMPLACEMENT VEHICLE

000	05/30/07	Initial Issue	Kenneth D. Draper <i>Kenneth D. Draper</i>	Robert A. Thornley <i>Robert A. Thornley</i>	Mark Johnson <i>Mark Johnson</i>	N/A
Rev.	Date	Reason for Revision	By Print Name and Sign	EGS/Lead Print Name and Sign	PE/RM Print Name and Sign	DEM Print Name and Sign
Document No.: 800-30R-HE00-01800-000				Rev.: 000

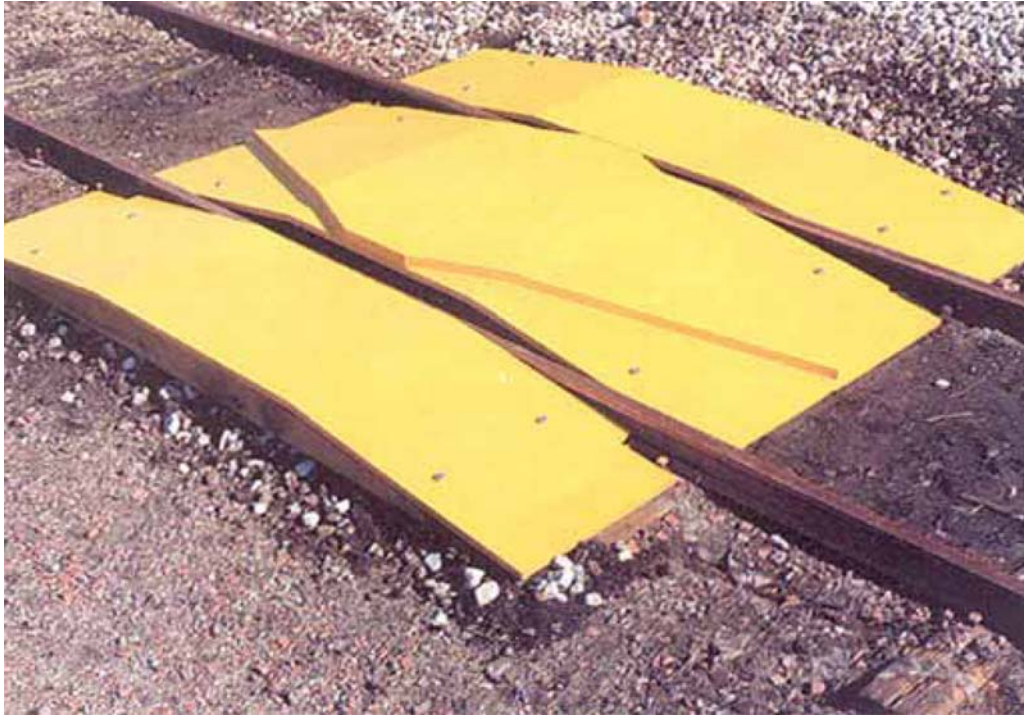
Figure 3.3-1: Rerailer

The derailment feet located on the TEV should allow the TEV to be dragged easily. The simplest solution would be to install rerailers, shown in Figure 3.3-1 near the derailed TEV. Attach a cable to the TEV then using an appropriate winch system, drag the TEV over the rerailer, which would put the TEV back on the rails. This solution is preferred as it reduces hands on operations.

The derailment feet located on the TEV should allow the TEV to be dragged easily. The simplest solution would be to use the MRV to install rerailers, shown in Figure 3.3-1 near the derailed TEV. The MRV would attach a cable to the TEV, actuate the rail clamps, then using the on-board winch drag the TEV over the rerailer, which would put the TEV back on the rails. This solution is preferred as it reduces hands on operations.
